**Flood Control Project Maintenance
Levee Inspections**

Fall 2013 Levee Maintenance Deficiency Summary Report

San Joaquin River Basin

Madera County FCWCA

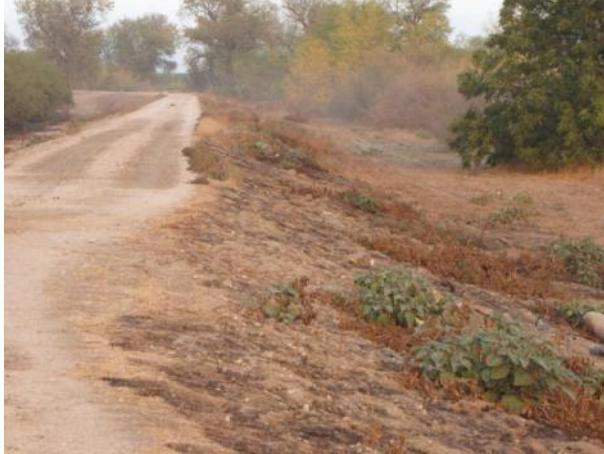
Levee Mile Report Line	4
Start Levee Mile	0.00
End Levee Mile	1.22
Location	Water Side
Category	Earthen Levee
Item	Vegetation
Looking upstream from levee mile 0.00 at the water side slope. Photo taken 11-07-2013.	
<i>phillips_f_20131112_462.JPG</i>

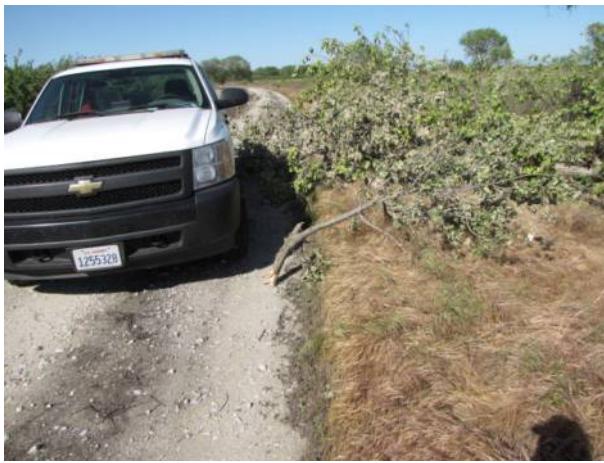
Levee Mile Report Line	16
Start Levee Mile	0.74
End Levee Mile	0.74
Location	Land Side
Category	Earthen Levee
Item	Encroachments
Dead tree on waterside crown, shoulder and slope unit 1, Ash Slough. Photo taken 4-17-2013.	
<i>phillips_f_20130925_460.JPG</i>

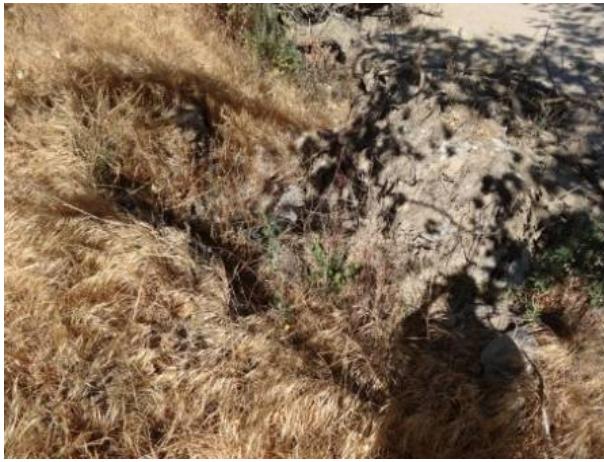
Levee Mile Report Line	20
Start Levee Mile	1.11
End Levee Mile	1.20
Location	Water Side
Category	Supplemental
Item	DWR Erosion Survey
Tree roots exposed.	
<i>SJR2013_NA0011U01RM2.57_3.jpg</i>

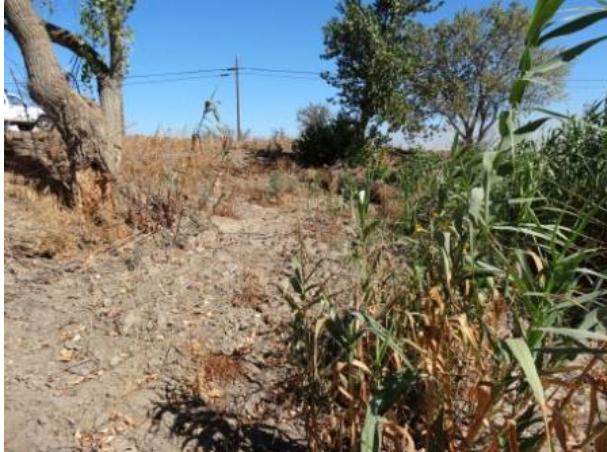
Levee Mile Report Line	25
Start Levee Mile	2.37
End Levee Mile	2.39
Location	Water Side
Category	Supplemental
Item	DWR Erosion Survey
Close view of the site. Note the trees and vegetation at site.	
SJR2013_NA0011U01RM3.8_3.jpg

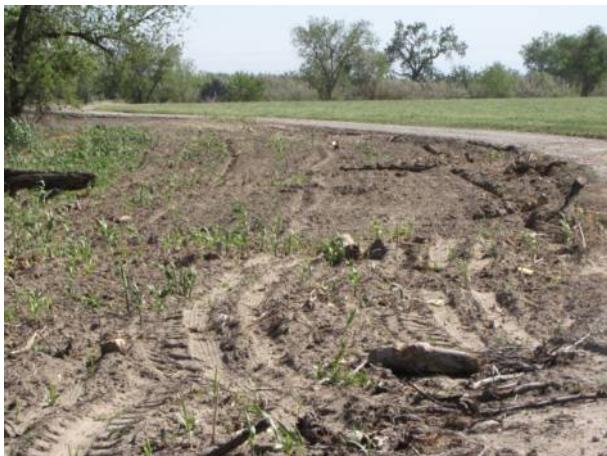
Y		
26	2.40	2.40	Earthen Levee	Vegetation	WS Ma	V2 : Remove the wild growth other than native grasses from the levee slopes. Inspector Comments: The farmer has plowed up the waterside berm too close to the levee toe causing damage to the levee toe. This method also transfers the bamboo roots along the berm. Spraying is needed to kill the new growth. This method of maintaining the waterside should not continue.		37.068737 ° -120.398570 °	37.068737 ° -120.396570 °	17		
										DWR ID: DWR_NA0011_01_s_2013_17

Levee Mile Report Line	26
Start Levee Mile	2.40
End Levee Mile	2.40
Location	Water Side
Category	Earthen Levee
Item	Vegetation
Ash Slough Levee mile 2.40 waterside berm. Farmer plowed too close. Damage to slope. Photo taken 4-17-2013.	
phillips_f_20130925_461.JPG

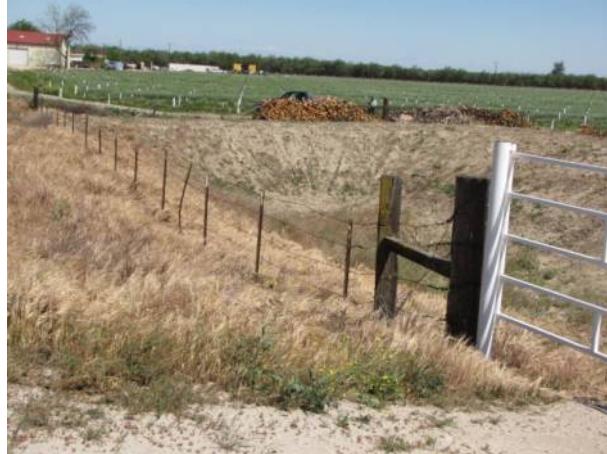
Levee Mile Report Line	2
Start Levee Mile	0.01
End Levee Mile	0.03
Location	Land Side
Category	Earthen Levee
Item	Encroachments
Ash Slough Levee mile 0.01-0.03 this settling basin was reported in Inspection 2012. no change Photo taken 4-17-2013.	phillips_f_20130925_493.JPG

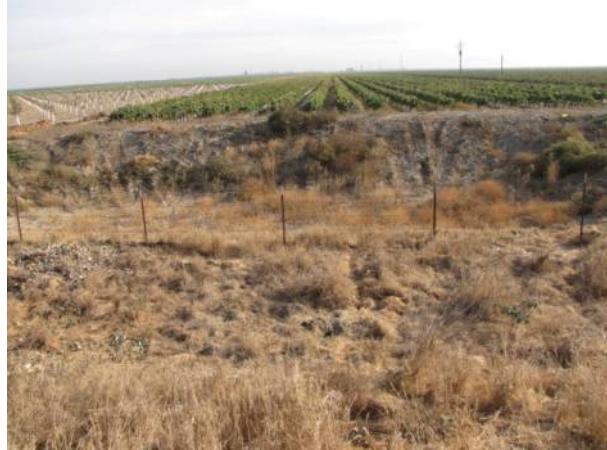
Levee Mile Report Line	2
Start Levee Mile	0.01
End Levee Mile	0.03
Location	Land Side
Category	Earthen Levee
Item	Encroachments
This settling basin was reported in last inspection, Spring 2013.	phillips_f_20131107_684.JPG

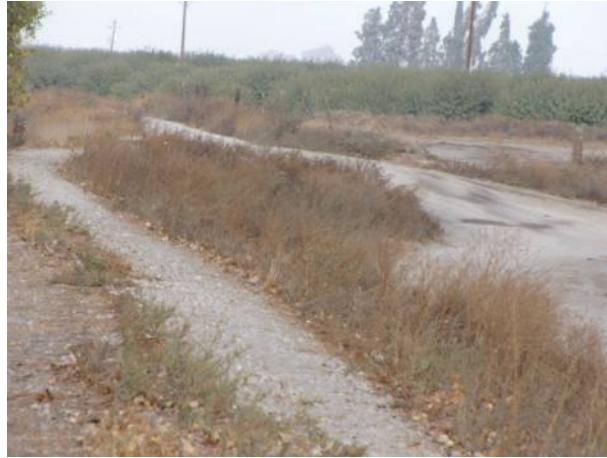
Levee Mile Report Line	15
Start Levee Mile	0.31
End Levee Mile	0.95
Location	Land Side
Category	Earthen Levee
Item	Vegetation
Weeds taller than 18-inches on landside shoulder and slope. Photo taken 11-07-2013.	phillips_f_20131107_686.JPG

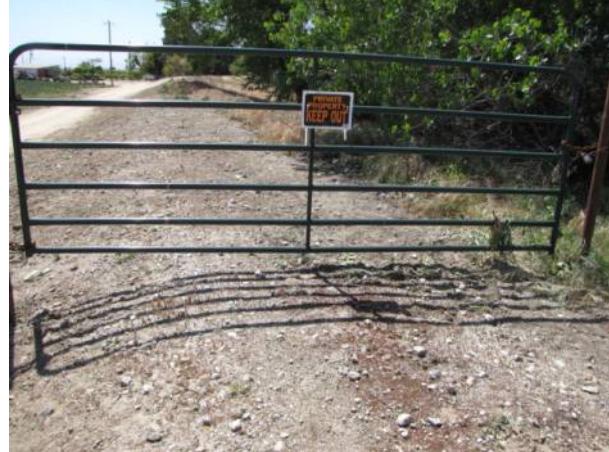
Levee Mile Report Line	16
Start Levee Mile	0.31
End Levee Mile	0.31
Location	Crown
Category	Earthen Levee
Item	Encroachments
Unauthorized gate and metal fence placed on slope and toe of levee section. Photo taken 4-17-2013.	
phillips_f_20130925_491.JPG

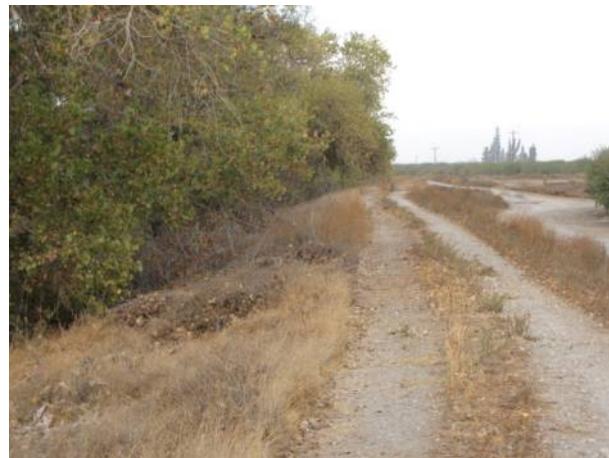
Levee Mile Report Line	17
Start Levee Mile	0.32
End Levee Mile	1.91
Location	Water Side
Category	Earthen Levee
Item	Vegetation
Unwanted growth on waterside slope. Weeds taller than 18-inches. Photo taken 11-07-2013.	
phillips_f_20131107_685.JPG

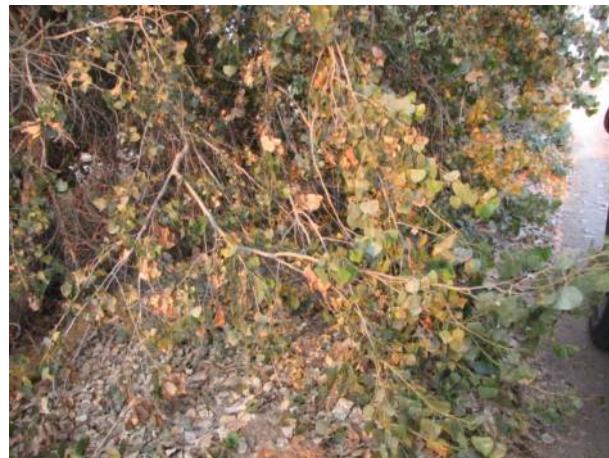
Levee Mile Report Line	33
Start Levee Mile	1.52
End Levee Mile	1.52
Location	Water Side
Category	Earthen Levee
Item	Trim / Thin Trees
This tree has limbs blocking slope and shoulder waterside of levee. Photo taken 11-07-2013.	
phillips_f_20131107_687.JPG

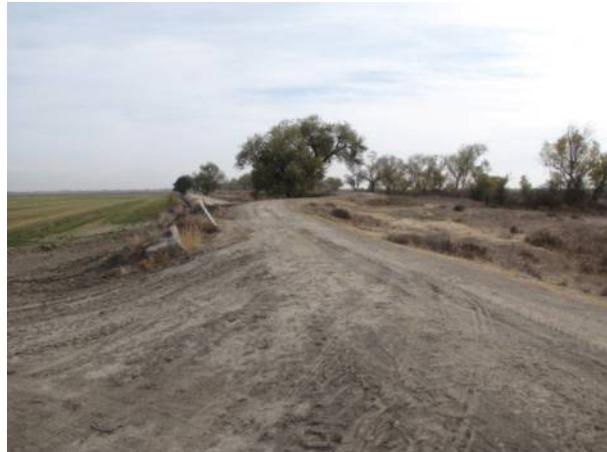
Levee Mile Report Line	2
Start Levee Mile	0.01
End Levee Mile	0.01
Location	Water Side
Category	Earthen Levee
Item	Vegetation
Unit 3 levee mile 0.01 landside and waterside slopes . Photo taken 11-07-2013.	
phillips_f_20131107_677.JPG

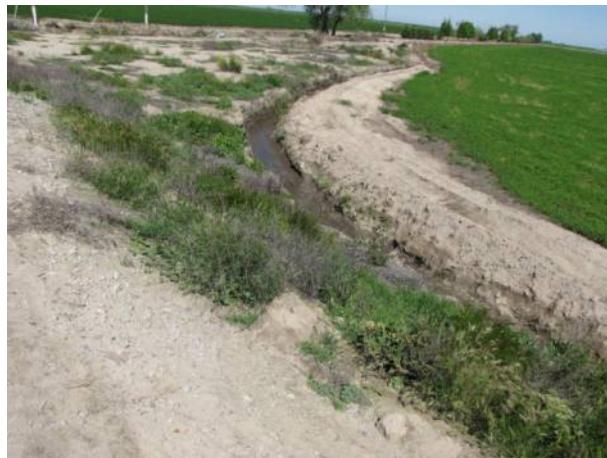
Levee Mile Report Line	5
Start Levee Mile	0.03
End Levee Mile	0.03
Location	Land Side
Category	Earthen Levee
Item	Encroachments
Agriculture ditch continues along land side within the 10-foot of levee toe. Photo taken 4-18-2012.	
phillips_f_20130925_525.jpg

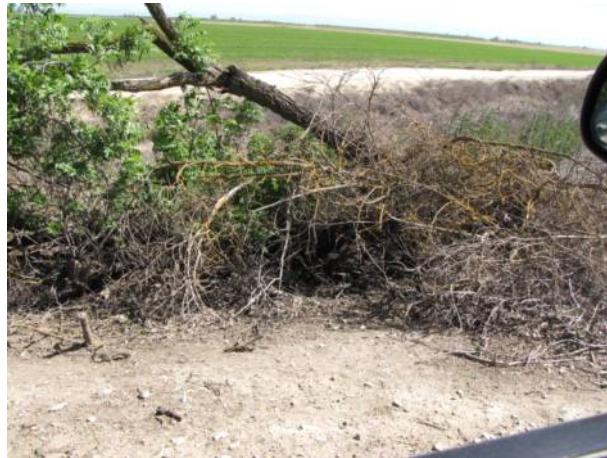
Levee Mile Report Line	12
Start Levee Mile	0.06
End Levee Mile	0.06
Location	Land Side
Category	Earthen Levee
Item	Encroachments
This tree has been reported several times, remove it from levee section. Photo taken 4-16-2013.	
phillips_f_20130925_526.JPG

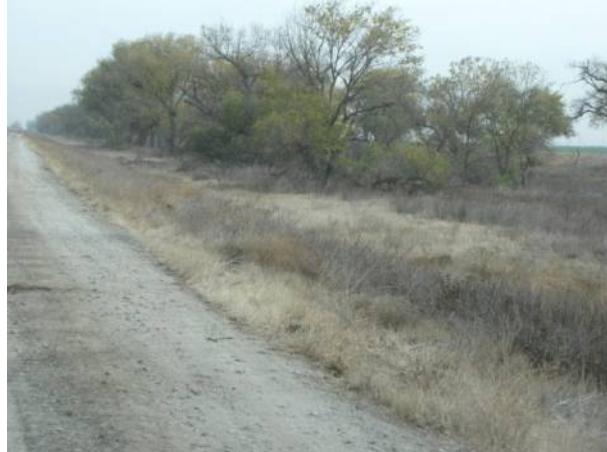
Levee Mile Report Line	15
Start Levee Mile	0.10
End Levee Mile	1.50
Location	Water Side
Category	Earthen Levee
Item	Vegetation
11-07-2013 weeds taller than 2-foot on waterside slope.	
phillips_f_20131113_691.JPG

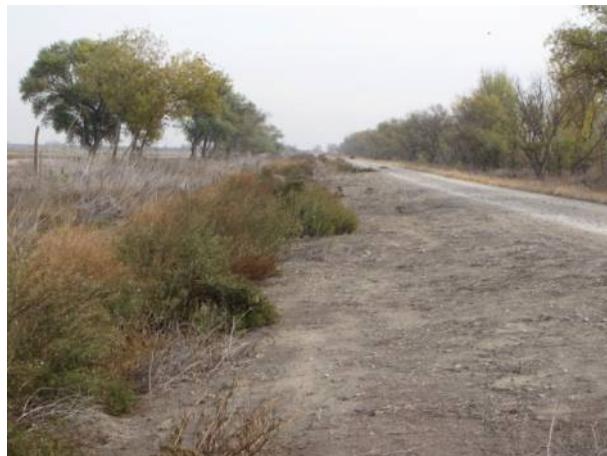
Levee Mile Report Line	17
Start Levee Mile	0.27
End Levee Mile	0.54
Location	Land Side
Category	Earthen Levee
Item	Vegetation
Tall weeds on land side. Photo taken 11-07-2013.	
phillips_f_20131113_692.JPG

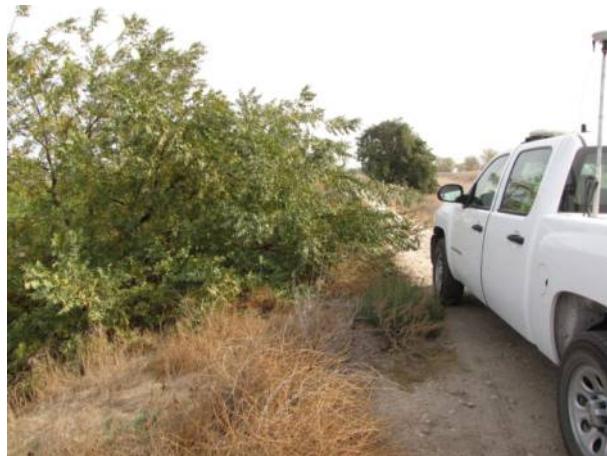
Levee Mile Report Line	20
Start Levee Mile	1.05
End Levee Mile	1.05
Location	Land Side
Category	Earthen Levee
Item	Trim / Thin Trees
Unsatisfactory growth of tree blocking roadway landward. Photo taken 11-07-2013.	
phillips_f_20131113_693.JPG

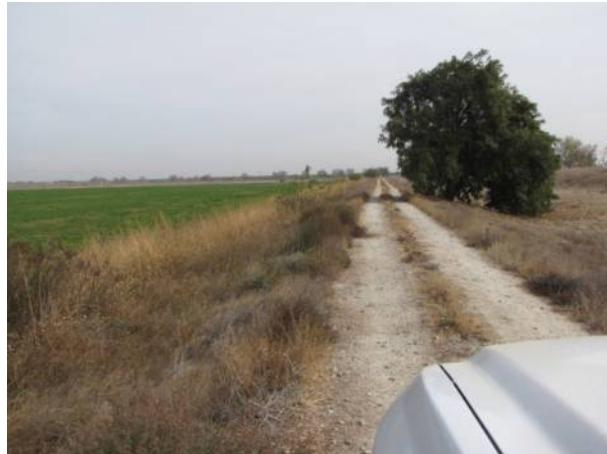
Levee Mile Report Line	26
Start Levee Mile	1.08
End Levee Mile	1.52
Location	Land Side
Category	Earthen Levee
Item	Vegetation
Landside growth taller than 2-foot extends to levee mile 1.52. Photo taken 11-07-2013.	
phillips_f_20131113_694.JPG

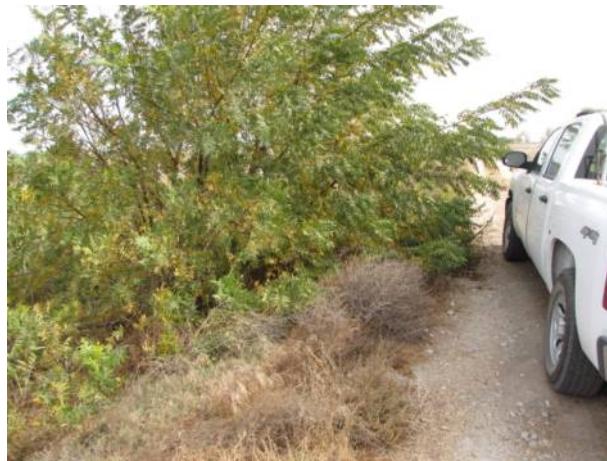
Levee Mile Report Line	36
Start Levee Mile	1.26
End Levee Mile	1.26
Location	Land Side
Category	Earthen Levee
Item	Trim / Thin Trees
Remove tree from levee section. Photo taken 11-07-2013.	
phillips_f_20131113_695.JPG

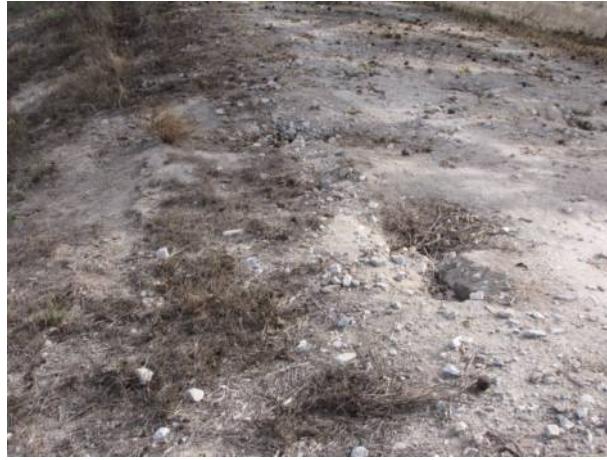
Levee Mile Report Line	40
Start Levee Mile	1.50
End Levee Mile	1.53
Location	Crown
Category	Earthen Levee
Item	Animal Control
There are several rodent holes in the shoulder and crown of the roadway.	
phillips_f_20130925_522.jpg

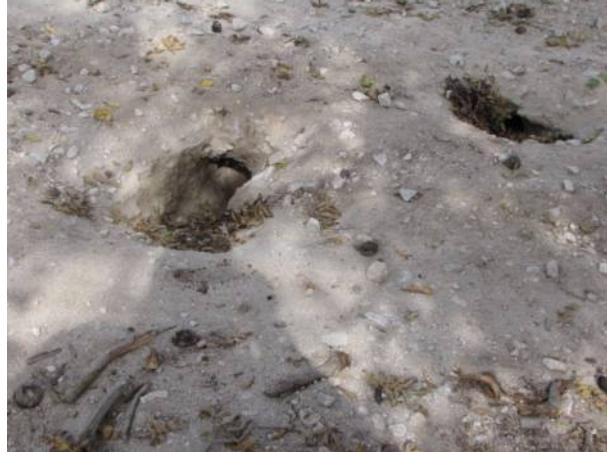
Levee Mile Report Line	40
Start Levee Mile	1.50
End Levee Mile	1.53
Location	Crown
Category	Earthen Levee
Item	Animal Control
This photo shows holes in crown and shoulder.	
phillips_f_20130925_523.jpg

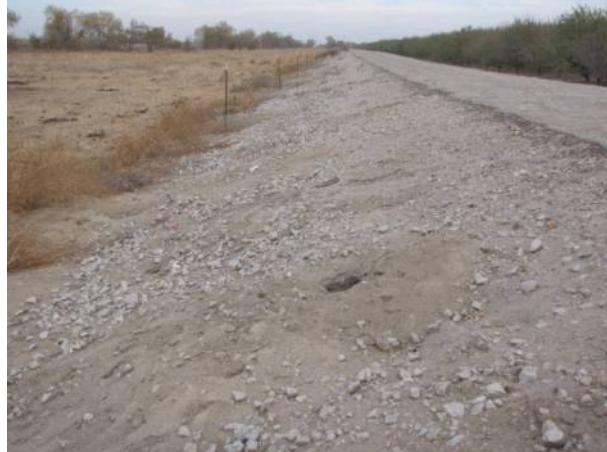
Levee Mile Report Line	31
Start Levee Mile	1.66
End Levee Mile	2.25
Location	Water Side
Category	Earthen Levee
Item	Animal Control
11-07-2013: Rodent activity has increased; no action to reduce population by the maintaining agency.	
phillips_f_20131113_688.JPG

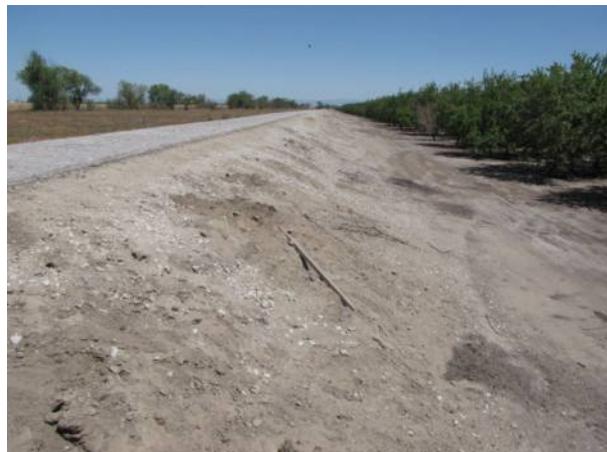
Levee Mile Report Line	32
Start Levee Mile	1.66
End Levee Mile	2.25
Location	Land Side
Category	Earthen Levee
Item	Animal Control
Rodents holes all over the levee section, this was noted in the Fall Inspection 2012. This new photo was taken 4-16-2013.	
phillips_f_20130925_544.JPG

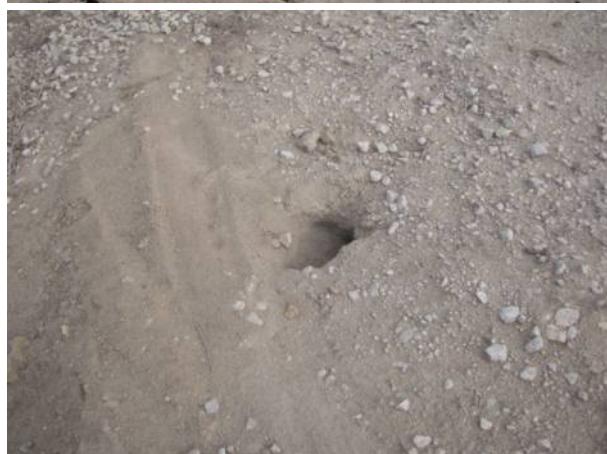
Levee Mile Report Line	32
Start Levee Mile	1.66
End Levee Mile	2.25
Location	Land Side
Category	Earthen Levee
Item	Animal Control
Activity around rodent hole there are several holes on the landward slope no bait stations in site. 11-07-2013.	
phillips_f_20131113_689.JPG

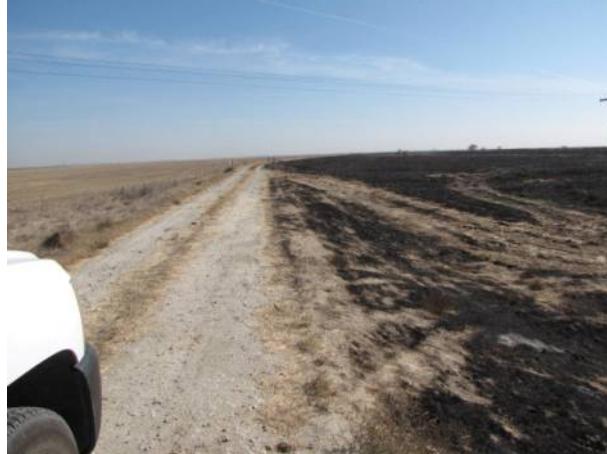
Levee Mile Report Line	6
Start Levee Mile	0.01
End Levee Mile	1.30
Location	Water Side
Category	Earthen Levee
Item	Vegetation
Unit 5 Fresno River levee mile 0.01-1.30 wild fire has burned the vegetation. Photo taken 11-06-2013.	
phillips_f_20131126_703.JPG

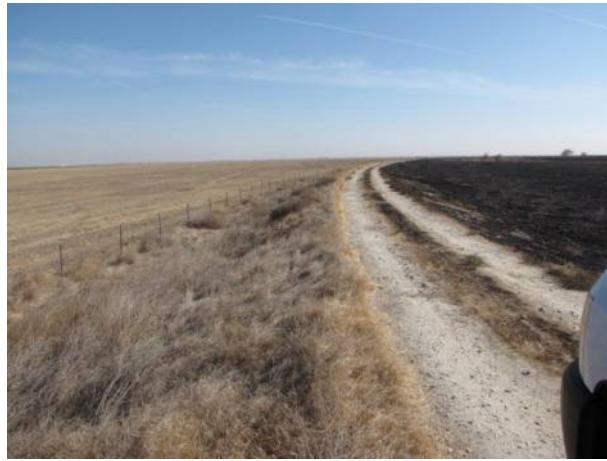
Levee Mile Report Line	7
Start Levee Mile	0.01
End Levee Mile	6.58
Location	Land Side
Category	Earthen Levee
Item	Vegetation
Fresno River Unit 5 land side slope. Weeds taller than 2-foot. Photo taken 11-06-2013.	
phillips_f_20131126_702.JPG

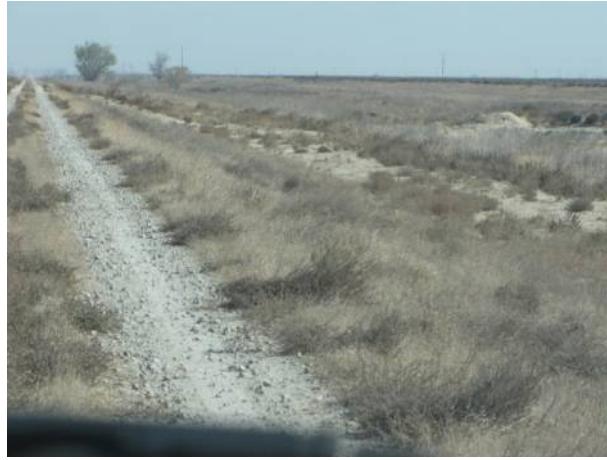
Levee Mile Report Line	19
Start Levee Mile	1.32
End Levee Mile	4.09
Location	Water Side
Category	Earthen Levee
Item	Vegetation
Weeds taller than 2-foot on the waterward side. Photo taken 11-06-2013	
phillips_f_20131126_704.JPG

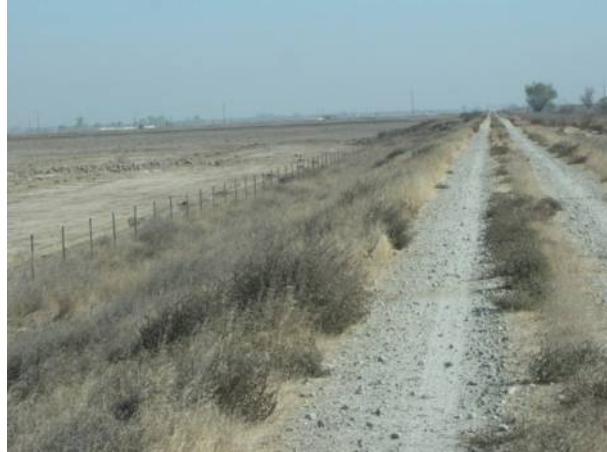
Levee Mile Report Line	20
Start Levee Mile	1.37
End Levee Mile	4.09
Location	Land Side
Category	Earthen Levee
Item	Vegetation
Fresno River unit 5 weeds taller than 2-foot. Photo taken 11-06-2013.	
phillips_f_20131126_705.JPG

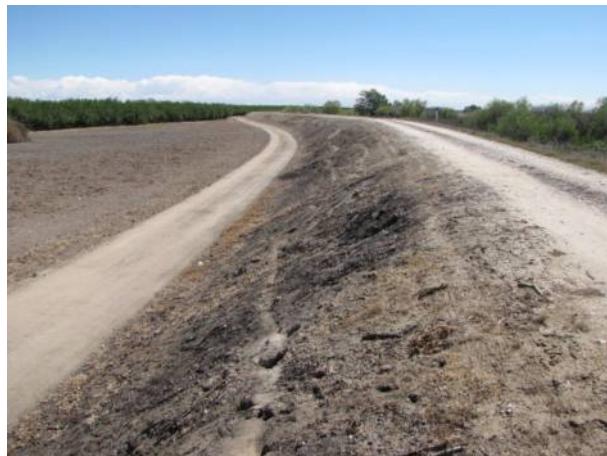
Levee Mile Report Line	34
Start Levee Mile	6.67
End Levee Mile	6.75
Location	Land Side
Category	Earthen Levee
Item	Animal Control
Fresno River Unit 5 unsatisfactory rodent control. Photo taken 4-16-2013.	
phillips_f_20130925_583.JPG

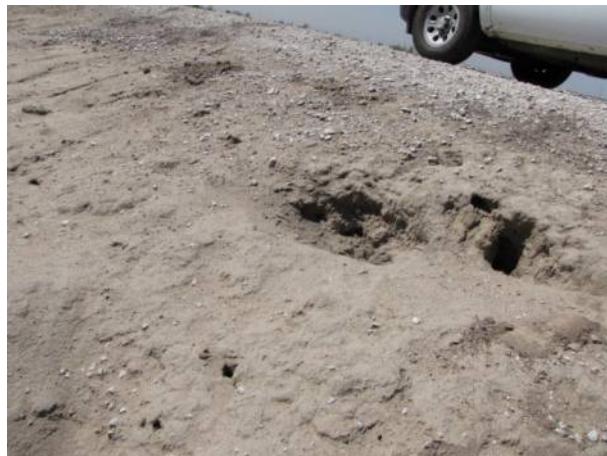
Levee Mile Report Line	34
Start Levee Mile	6.67
End Levee Mile	6.75
Location	Land Side
Category	Earthen Levee
Item	Animal Control
Continue rodent holes out of control. Photo taken 4-16-2013.	
phillips_f_20130925_584.JPG

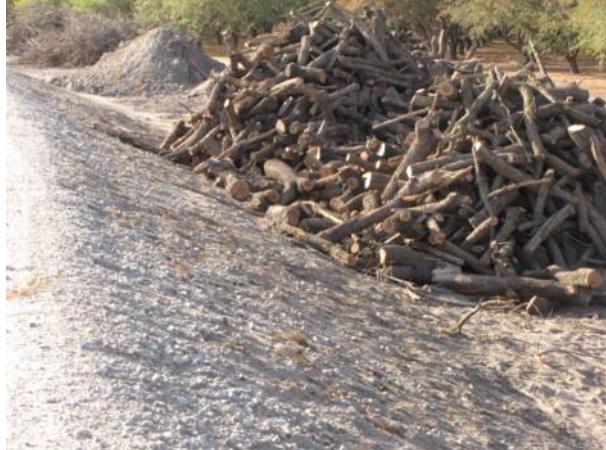
Levee Mile Report Line	42
Start Levee Mile	8.49
End Levee Mile	8.50
Location	Land Side
Category	Earthen Levee
Item	Encroachments
Firewood on land side toe and slope. Photo taken 11-06-2013.	
phillips_f_20131126_706.JPG
